**Flood Control Project Maintenance
Levee Inspections**

Maintenance Issue Types Only, Levee Inspection Report By Mile - Spring 2017

Yolo County Department of Natural Resources

Waterway	Bank	Unit Miles	Inspection Start/End	Inspector
Unit No. 01 Right Bank Cache Creek	Right	0.59	04/06/2017 04/06/2017	Zach Jojola

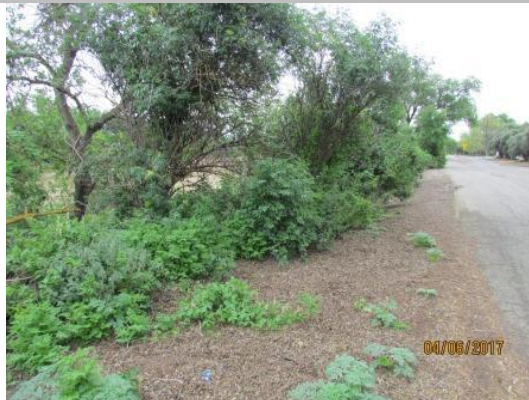
Photo 1 of 1 : SP_2017_NA0021_351_23_20170413_00031.jpg

Wild vegetation on waterside levee slope, blocking visibility. Spring 2017.

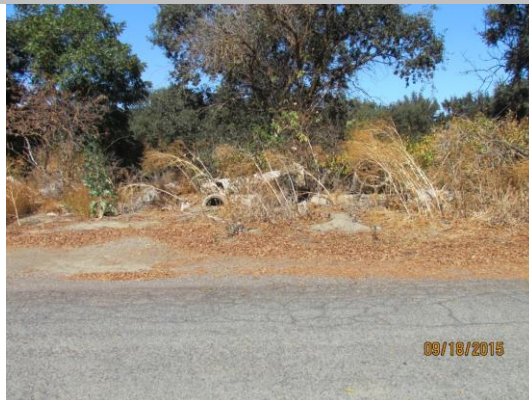
Photo 1 of 1 : SP_2017_NA0021_351_15_20170320_00015.jpg

View of the debris on the waterward side of the levee. Fall 2015.

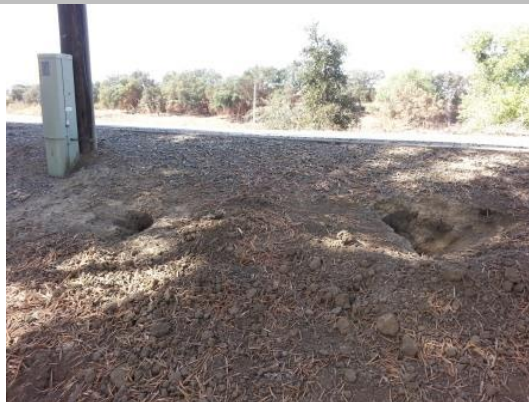
Photo 1 of 3 : SP_2017_NA0021_351_16_20170320_00016.jpg

LM Start	0.19	Rating **	U	Issue No.	16
LM End	0.19	Issue Type +	Ma	Location *	LS
Category	Earthen Levee			GPS Latitude/Longitude	
				Start	End
Item	Animal Control			38.721536 °	38.721536 °
				-121.807711 °	-121.807711 °
DWR ID	DWR_NA0021_01_s_2015_16				
Comment Code					
A3 : No rodents visible, but rodent burrows visible; need to backfill and compact or grout burrows.					
Inspector Comment

An updated view of rodent holes on LS slope. Fall inspection 10/07/2016.

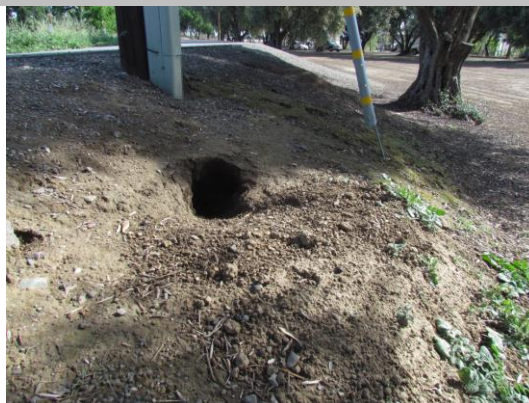
Photo 2 of 3 : SP_2017_NA0021_351_16_20170320_00017.jpg

LM Start	0.19	Rating **	U	Issue No.	16 (cont)	
LM End	0.19	Issue Type +	Ma	Location *	LS	
Category	Earthen Levee			GPS Latitude/Longitude		
				Start		End
Item	Animal Control			38.721536 °		38.721536 °
				-121.807711 °		-121.807711 °
DWR ID	DWR_NA0021_01_s_2015_16					
Comment Code						
A3 : No rodents visible, but rodent burrows visible; need to backfill and compact or grout burrows.						
Inspector Comment

View of the rodent hole on the landward side of the levee looking downstream. Spring 2015.

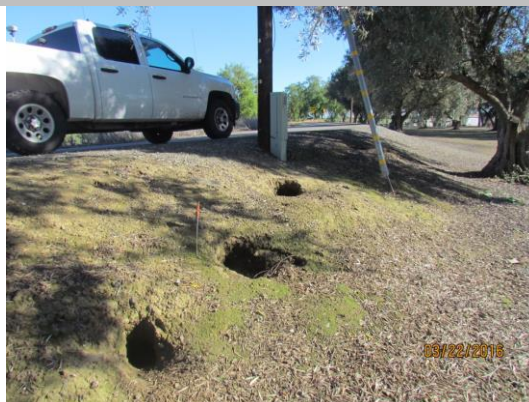
Photo 3 of 3 : SP_2017_NA0021_351_16_20170320_00018.jpg

View of the rodent holes on the landward side of the levee looking downstream. Spring 2016.

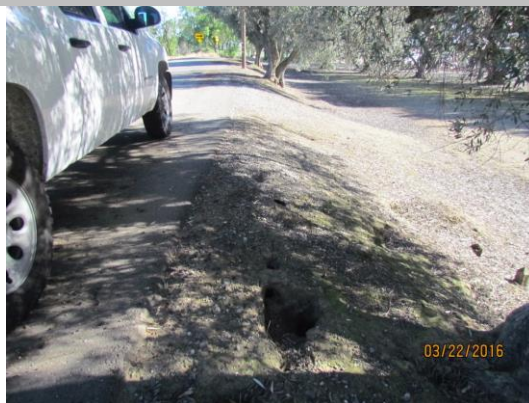
Photo 1 of 2 : SP_2017_NA0021_351_7_20170320_00007.jpg

LM Start	0.20	Rating **	M	Issue No.	7
LM End	0.20	Issue Type +	Ma	Location *	LS
Category	Earthen Levee			GPS Latitude/Longitude	
				Start	End
Item	Animal Control			38.721683 °	38.721683 °
				-121.807532 °	-121.807532 °
DWR ID	DWR_NA0021_01_s_2016_7				
Comment Code					
A3 : No rodents visible, but rodent burrows visible; need to backfill and compact or grout burrows.					
Inspector Comment

Perspective view of the rodent hole on the landward side of the levee looking downstream. Spring 2016.

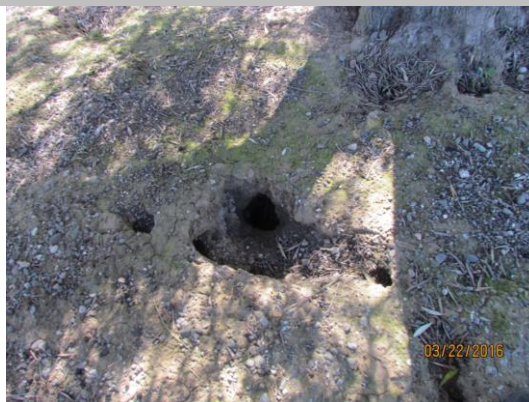
Photo 2 of 2 : SP_2017_NA0021_351_7_20170320_00008.jpg

Animal hole is close to the shoulder of the levee. Spring 2016.

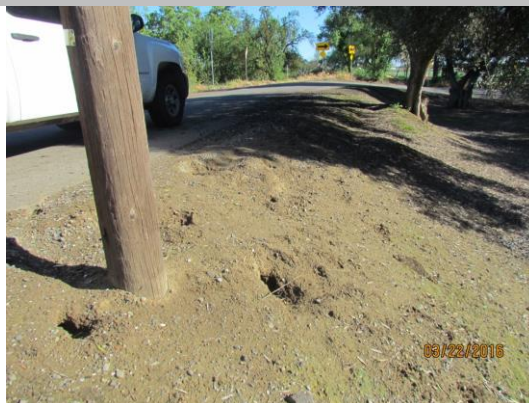
Photo 1 of 1 : SP_2017_NA0021_351_8_20170320_00009.jpg

LM Start	0.22	Rating **	M	Issue No.	8
LM End	0.22	Issue Type +	Ma	Location *	LS
Category	Earthen Levee			GPS Latitude/Longitude	
				Start	End
Item	Animal Control			38.721876 °	38.721876 °
				-121.807393 °	-121.807393 °
DWR ID	DWR_NA0021_01_s_2016_8				
Comment Code					
A3 : No rodents visible, but rodent burrows visible; need to backfill and compact or grout burrows.					
Inspector Comment

View of the rodent holes on the landward side of the levee looking downstream. Spring 2016.

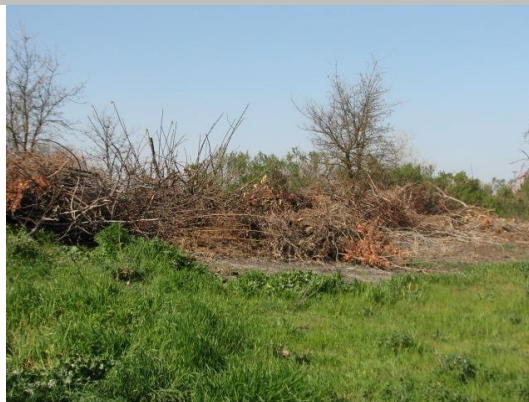
Photo 1 of 3 : SP_2017_NA0021_351_4_20170320_00003.jpg

LM Start	0.26	Rating **	M	Issue No.	4
LM End	0.26	Issue Type +	Ma	Location *	WS
Category	Earthen Levee			GPS Latitude/Longitude	
				Start	End
Item	Encroachments			38.722418 °	38.722418 °
				-121.806999 °	-121.806999 °
DWR ID	DWR_NA0021_01_s_2012_4				
Comment Code					
PR : Prunings					
Inspector Comment

A continuous brush pile on levee. Spring 2013

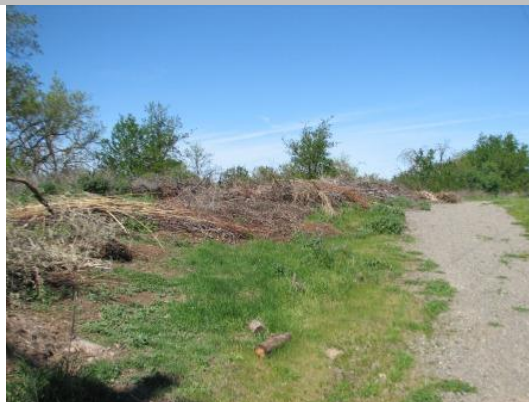
Photo 2 of 3 : SP_2017_NA0021_351_4_20170320_00004.jpg

The brush pile did not get burned this last winter. Spring 2014

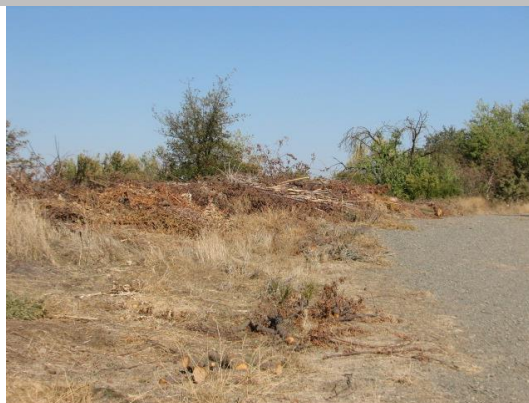
Photo 3 of 3 : SP_2017_NA0021_351_4_20170320_00005.jpg

LM Start	0.26	Rating **	M	Issue No.	4 (cont)	
LM End	0.26	Issue Type +	Ma	Location *	WS	
Category	Earthen Levee			GPS Latitude/Longitude		
				Start		End
Item	Encroachments			38.722418 °		38.722418 °
				-121.806999 °		-121.806999 °
DWR ID	DWR_NA0021_01_s_2012_4					
Comment Code						
PR : Prunings						
Inspector Comment

The latest look of the ongoing brush pile. Fall 2013

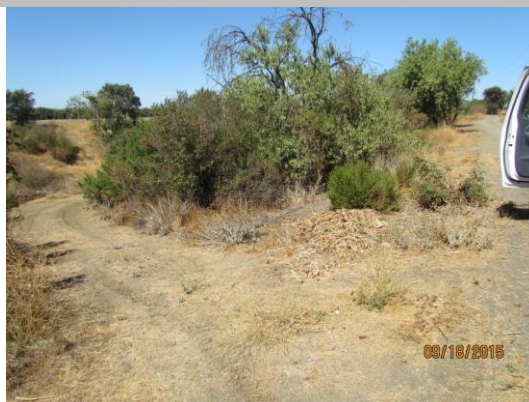
Photo 1 of 3 : SP_2017_NA0021_351_22_20170320_00025.jpg

LM Start	0.27	Rating **	M	Issue No.	22
LM End	0.27	Issue Type +	Ma	Location *	WS
Category	Earthen Levee			GPS Latitude/Longitude	
				Start	End
Item	Slope Stability			38.722620 °	38.722620 °
				-121.806958 °	-121.806958 °
DWR ID	DWR_NA0021_01_f_2015_22				
Comment Code					
S3 : Repair the levee slope damaged by vehicle traffic and prevent access where possible.					
Inspector Comment					
A vehicle ramp seems to have been made.

Perspective view of the trail on the waterward side of the levee looking downstream. Fall 2015.

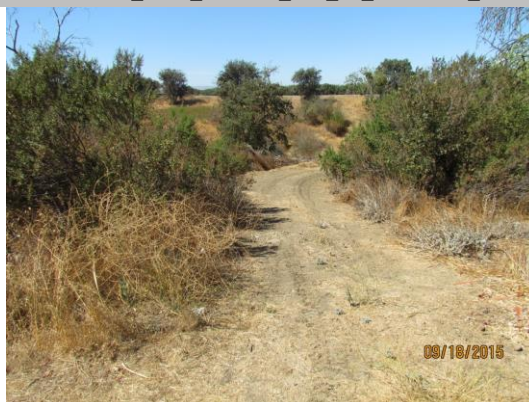
Photo 2 of 3 : SP_2017_NA0021_351_22_20170320_00026.jpg

View of the trail on the waterward side of the levee. Fall 2015.

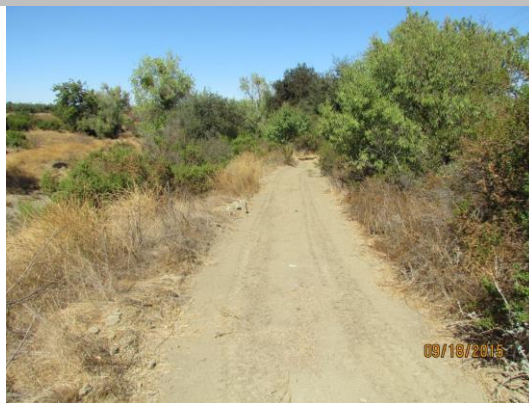
Photo 3 of 3 : SP_2017_NA0021_351_22_20170320_00027.jpg

LM Start	0.27	Rating **	M	Issue No.	22 (cont)	
LM End	0.27	Issue Type +	Ma	Location *	WS	
Category	Earthen Levee			GPS Latitude/Longitude		
				Start		End
Item	Slope Stability			38.722620 °		38.722620 °
				-121.806958 °		-121.806958 °
DWR ID	DWR_NA0021_01_f_2015_22					
Comment Code						
S3 : Repair the levee slope damaged by vehicle traffic and prevent access where possible.						
Inspector Comment						
A vehicle ramp seems to have been made.

The trail seems to be an access point that leads down to Cache Creek.
Fall 2015.

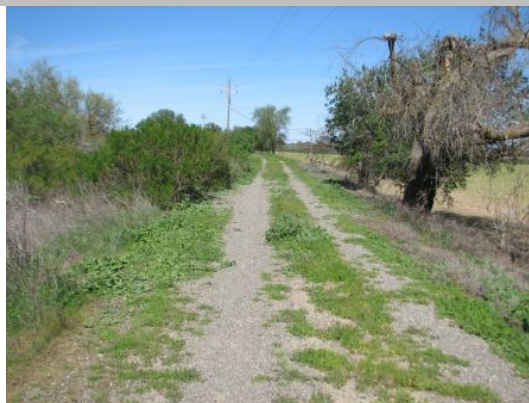
Photo 1 of 1 : SP_2017_NA0021_351_13_20170320_00014.jpg

LM Start	0.30	Rating **	M	Issue No.	13
LM End	0.50	Issue Type +	Ma	Location *	CR
Category	Earthen Levee			GPS Latitude/Longitude	
				Start	End
Item	Vegetation			38.723017 °	38.725844 °
				-121.806879 °	-121.806516 °
DWR ID	DWR_NA0021_01_s_2014_13				
Comment Code					
V9 : Keep the crown roadway free of vegetation.					
Inspector Comment

Vegetation on the crown needs to be controlled. Spring 2014

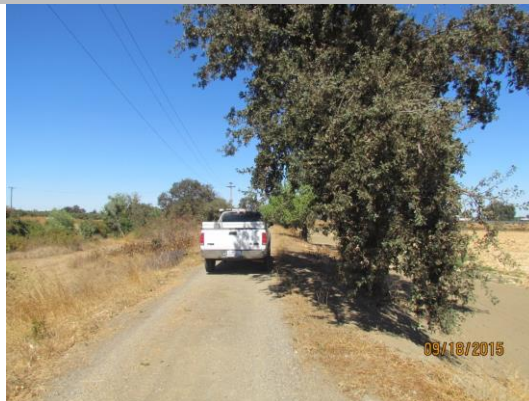
Photo 1 of 1 : SP_2017_NA0021_351_6_20170320_00006.jpg

LM Start	0.36	Rating **	M	Issue No.	6
LM End	0.36	Issue Type +	Ma	Location *	LS
Category	Earthen Levee			GPS Latitude/Longitude	
				Start	End
Item	Trim / Thin Trees			38.723903 °	38.723903 °
				-121.806613 °	-121.806613 °
DWR ID	DWR_NA0021_01_s_2012_6				
Comment Code					
T1 : Trim trees to at least five feet above ground level.					
Inspector Comment

View of the tree on the landward side of the levee looking downstream. Fall 2015.

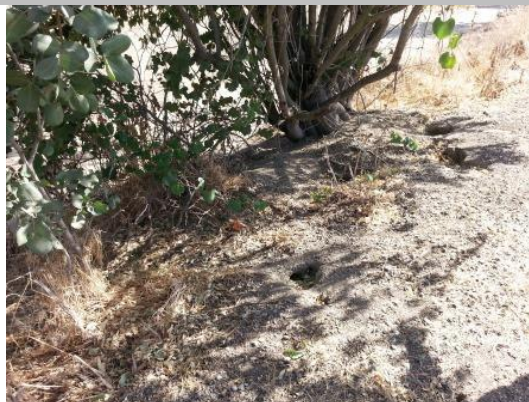
Photo 1 of 1 : SP_2017_NA0021_351_2_20170320_00001.jpg

LM Start	0.40	Rating **	M	Issue No.	2
LM End	0.40	Issue Type +	Ma	Location *	LS
Category	Earthen Levee			GPS Latitude/Longitude	
				Start	End
Item	Animal Control			38.724437 °	38.724437 °
				-121.806620 °	-121.806620 °
DWR ID	DWR_NA0021_01_f_2016_2				
Comment Code					
A3 : No rodents visible, but rodent burrows visible; need to backfill and compact or grout burrows.					
Inspector Comment

Rodent holes on LS slope. Fall inspection 10/07/2016.

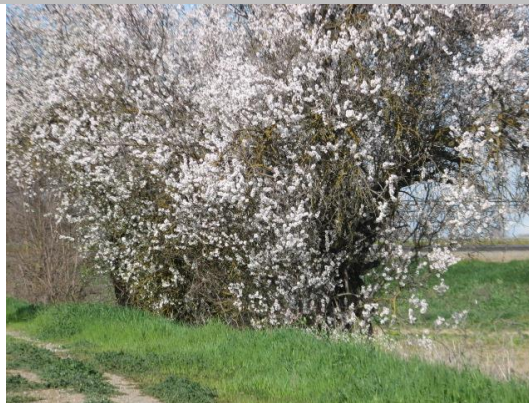
Photo 1 of 2 : SP_2017_NA0021_351_9_20170320_00010.jpg

LM Start	0.44	Rating **	M	Issue No.	9
LM End	0.44	Issue Type +	Ma	Location *	LS
Category	Earthen Levee			GPS Latitude/Longitude	
				Start	End
Item	Trim / Thin Trees			38.725022 °	38.725022 °
				-121.806478 °	-121.806478 °
DWR ID	DWR_NA0021_01_s_2012_9				
Comment Code					
T1 : Trim trees to at least five feet above ground level.					
Inspector Comment

Trees need to be trimmed to 5'. Spring 2013

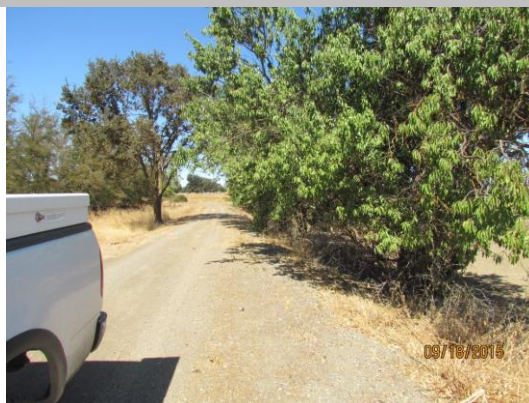
Photo 2 of 2 : SP_2017_NA0021_351_9_20170320_00011.jpg

View of the tree that needs to be trimmed on the landward side of the levee looking downstream. Fall 2015.

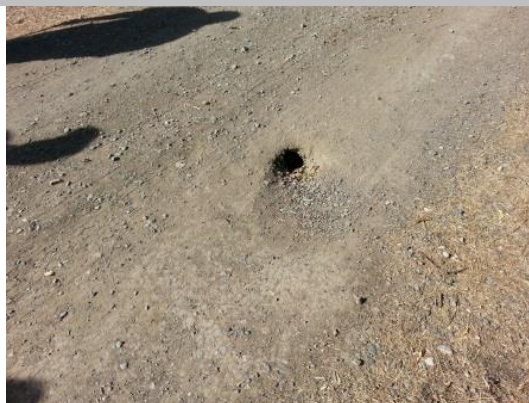
Photo 1 of 1 : SP_2017_NA0021_351_3_20170320_00002.jpg

LM Start	0.44	Rating **	M	Issue No.	3
LM End	0.44	Issue Type +	Ma	Location *	CR
Category	Earthen Levee			GPS Latitude/Longitude	
				Start	End
Item	Animal Control			38.725087 °	38.725087 °
				-121.806502 °	-121.806502 °
DWR ID	DWR_NA0021_01_f_2016_3				
Comment Code					
A3 : No rodents visible, but rodent burrows visible; need to backfill and compact or grout burrows.					
Inspector Comment

Rodent holes on levee crown. No live rodents observed. Fall inspection 10/07/2016.
